**UPSTREAM DAM
MADISON COUNTY, MISSOURI
MO 31080**

PHASE I INSPECTION REPORT NATIONAL DAM SAFETY PROGRAM

JUNE 1979

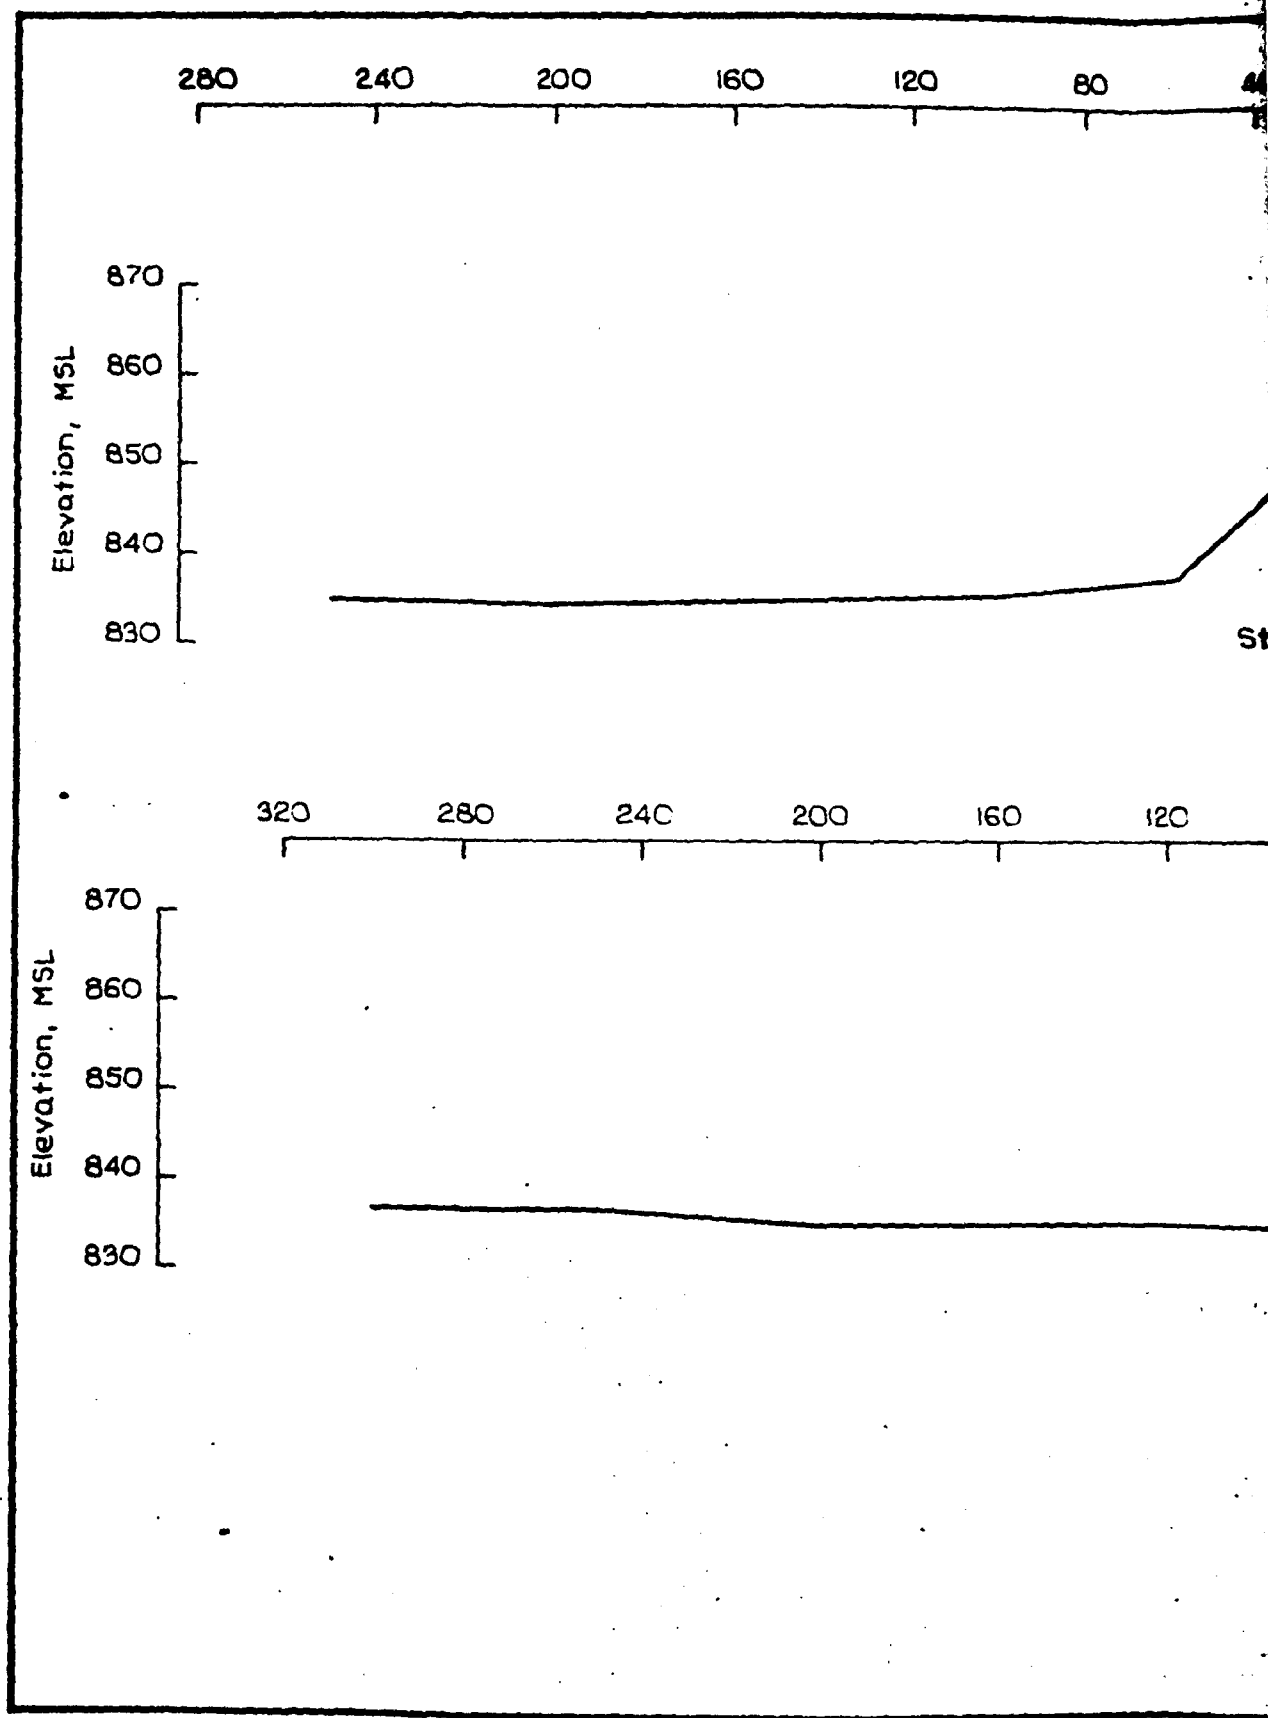
5
PLATE 5

Tailings Dam. The channel profile is shown on Plate 5 and cross-sections are presented in Plates 7A through E and Plate 8. Detailed hydraulic analysis of the flow conditions along the entire length of the channel is beyond the scope of this study.

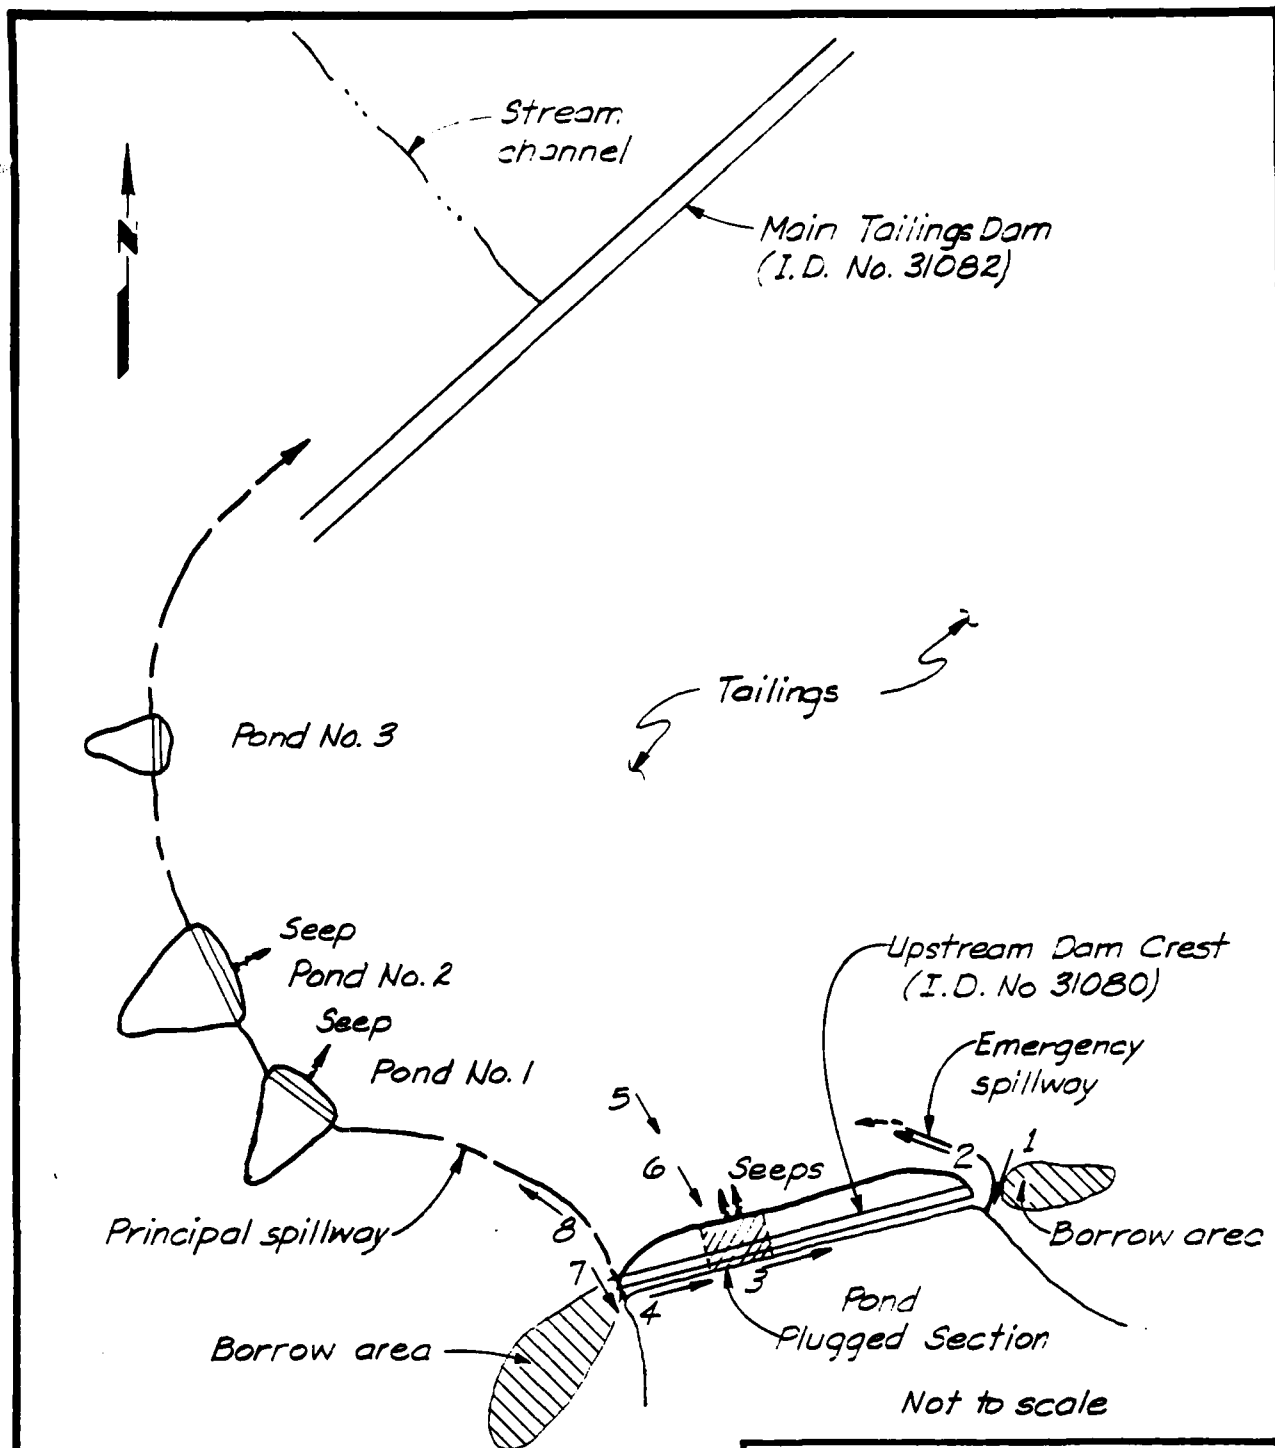
1 B PLATE 8

2. Emergency Spillway - The emergency spillway is located at the east end of the embankment. The spillway cross-section is presented in Plate 8. The spillway crest is at El. 860.0, which is 4 feet higher than the principal spillway crest elevation. Two methods were used to derive the emergency spillway rating curve:
